## Power2009-81019

### IDENTIFICATION OF ABNORMAL ROTOR DYNAMIC STIFFNESS USING MEASURED VIBRATION INFORMATION AND ANALYTICAL MODELING

Ned M. Endres, Principal MDS Specialist

RoMaDyn Corporation

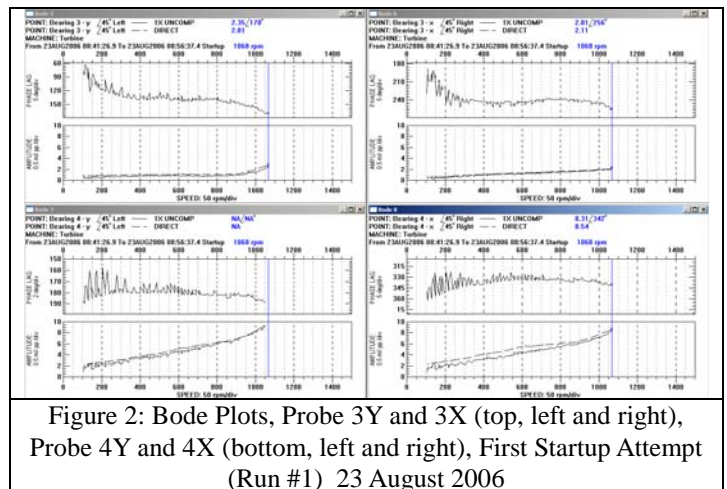
Figure 2: Bode Plots, Probe 3Y and 3X (top, left and right), Probe 4Y and 4X (bottom, left and right), First Startup Attempt (Run #1) 23 August 2006

An initial field balance and vibration analysis was performed on an Allis Chalmers 45 MW steam turbine generator from 21 to 25 August 2006. As mentioned previously, initial data acquired by the plant personnel covering the period from 1 to 13 August 2006 was forwarded to offsite RoMaDyn personnel for analysis and recommendations. This data indicated that the unit was operating at between 4-5 mil pp at bearing #4, and approaching 10-mil pp during startup and shutdown as the LP Turbine rotor passed through its first balance response region from 1000 to 1600 rpm. The data showed clear evidence of unbalance. Upon RoMaDyn traveling to site, an attempt to field balance the LP turbine was made on 23 August 2006. Initially, the unbalance state was severe enough that the unit could not pass through its first balance resonance and remain below 10-mil pp at bearing #4, see figure 2.

Based on the vibration data to 1068 rpm, a balance weight correction was added to #4 bearing balance plane (LP turbine) of 260 grams @ 105° (against rotation from the 4X probe; balance hole #21). This correction weight allowed the unit to pass through its first balance resonance. At 2880 rpm, the unit was returned to turning gear due to the rapid rise in the 1X synchronous vibration; see Figure 3 and the weight plane map in sketch 1.

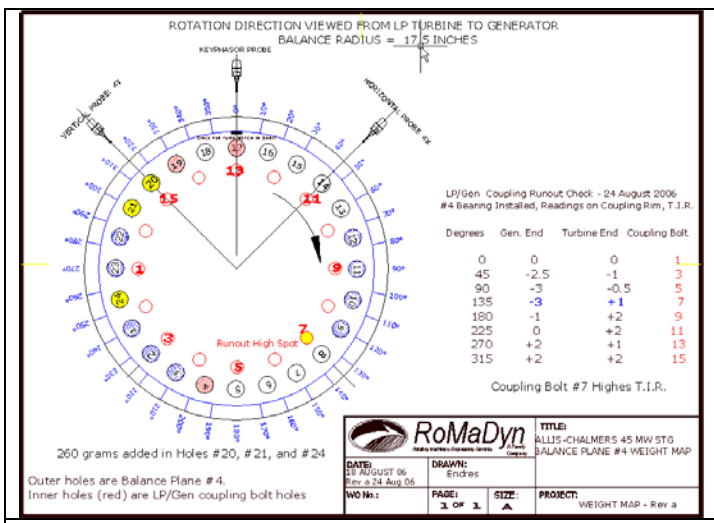
Sketch 1: Weight Plane Map After Balancing Attempt

A second balance correction was made by adding an additional 260 grams @ 90° (balance hole #20) and 260 grams @ 150° (balance hole #24). With the three weights added from both Runs #1 and #2, the net combined effect was 704.69 grams @ 115°; between balance holes #21 and #22, see figure 4 and the weight plane map.

This additional balance weight allowed the unit to be brought up to 3220 rpm before probe 4Y exceeded 10 mil pp. The response through the first balance resonance had been reduced from 10-mil pp (Run #2, Probe 4Y) to approximately 6.5 mil @ 1250 rpm (Run #3, Probe 4Y). Although the unit was responding positively to correction weights, its behavior was significantly different when compared to previous balance corrections (April 1992). In 1992, approximately 70 grams was required to reduce the synchronous 1X vibration by 1 mil pp. On 23 August 2006, it was taking approximately 140 grams to reduce the 1X vibration by 1 mil pp. One of the assumptions in balancing is linearity and repeatability, i.e. the system's response to corrective balancing does not change with time for a given set of operating conditions. Clearly, from April 1992 when the LP turbine rotor was successfully field balanced to 23 August 2006, the sensitivity of the LP turbine rotor had decreased, i.e. twice as much weight was required in 2006 for the same effect that was observed in 1992.

A runout check of the LP Turbine / Generator Coupling was made on August 24. The measured runout indicated that the coupling (shaft) centerlines were not within the 1 mil offset tolerance. Maximum T.I.R. of 3-4 mils was indicated at coupling bolt #7, which was in line with the unbalance location, see weight plane map above. After reviewing runout measurements for bearing #4 from 1992, there was no evidence

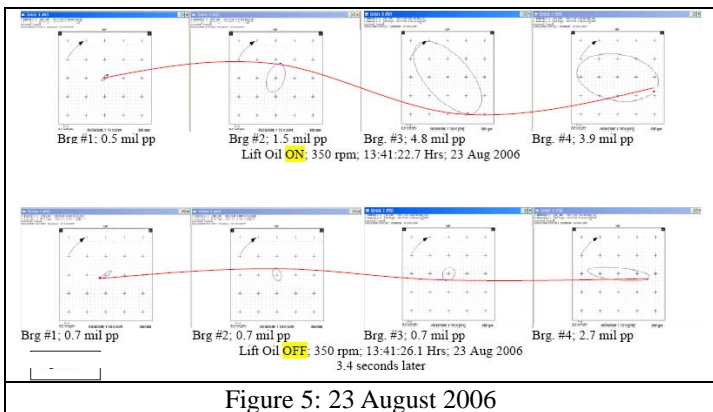
Figure 5: 23 August 2006

One significant indication that rotor stiffness had been affected was the change in slow roll behavior at 350 rpm while lift oil was switched on and off. In general, at rotor speed equal to and below 10% of operating speed (3600 rpm), vibration levels should be due to electrical (residual magnetism, noise ...) and/or mechanical slow roll or “glitch” at the proximity probe target area. With the lift oil switched on, the shaft average centerline positions at both bearings #3 and #4 rose. Shaft relative orbits clearly showed dynamic motion at 350 rpm. The indicated “heavy spot” at bearings #3 and #4 were in good agreement with the polar plot data from the balancing attempts, see figure 5, top. When the lift oil was turned off at 350 rpm, the rotor moved downward approximately 3 mils at bearing #3 and 2 mils at bearing #4. At 350 rpm, the apparent dynamic motion at bearing #3 was much higher with the lift oil switched on. This observed effect of the rotor being lifted more at bearing #3 and increased rotor static deflection was possibly due to opening of the suspected shaft crack. When the lift oil was switched off, rotor motion was downward, dynamic motion decreased due to a reduction in static deflection, and the suspected crack at bearing #3 partially closed (figure 5, bottom). By floating the rotor while on lift oil, shaft crack was opened and resulted in increased deflections. The above behavior suggests that a possible cracked shaft somewhere in the LP turbine rotor might be responsible for observed behavior.

At 1210 rpm (first balance resonance) on 23 August 2006, the rotor deflection shape looked essentially the same as it did at 350 rpm when the lift oils was switched off, see figure 5 bottom plot, with the majority of the motion being at bearing #4 in the horizontal plane. By comparing the deflection shapes on 13 August 2006 to those of 23 August 2006, very little change was observed at bearings #1 and #2. However, the phase angle of the high spot in orbit of bearing #3 had changed 180 degrees, and the orbit motion at bearing #4 had shifted from being mostly vertical to primarily horizontal, see figure 6. Again, this type of behavior tended to suggest that a possible cracked shaft

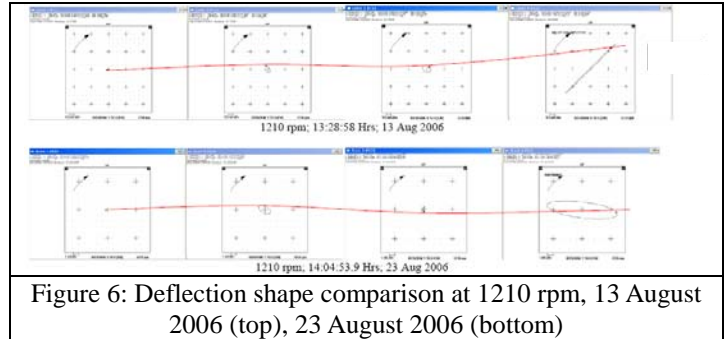
somewhere in the LP turbine rotor might be responsible for observed vibration characteristics.

Figure 6: Deflection shape comparison at 1210 rpm, 13 August 2006 (top), 23 August 2006 (bottom)

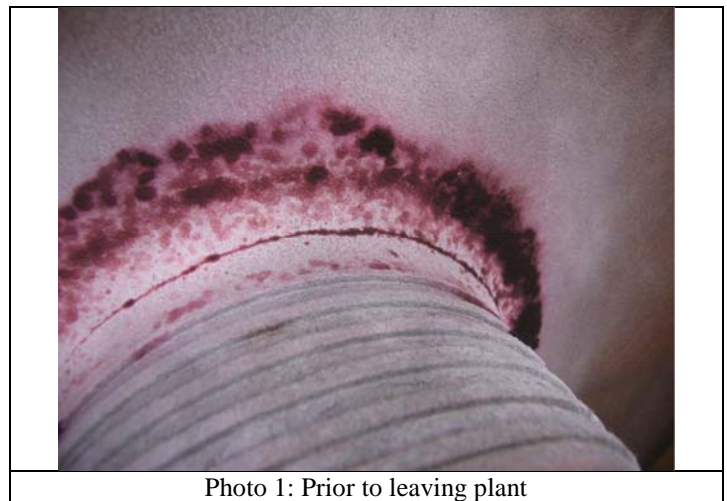
Photo 1: Prior to leaving plant

Since the vibration data and results of initial balancing of the turbine suggested that a potential shaft crack might be present, the unit was taken offline for an inspection. On 25 August the decision was made to completely disassembly the LP turbine and generator for inspection. These rotors were removed and shipped to an outside repair facility for inspection and repair. NDE inspections consisted of boreside visual examination, wet fluorescent magnetic particle testing, and ultrasonic testing. The inspection of LP turbine rotor revealed a 260-270 degree circumferential crack on the #3 bearing end of the LP rotor. The crack was located between the gland seals and last stage wheel, photo 1 and photo 2.

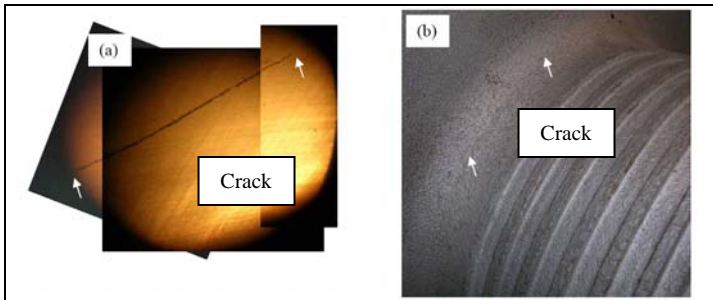
The appearance of the crack near bearing #3 gland seal posed a significant question. Why were the 1X synchronous vibrations higher at bearing #4 when the rotor crack was near bearing #3? The answer was not immediately obvious. Therefore, RoMaDyn was requested to perform an analytical analysis of the rotor system and investigate (compute) the effects of potential rotor cracks near bearing #3 on rotor mode shapes and balance response.

Photo2: a) Bore surface connected circumferential crack, about 1.5 inches long and spanning 51 degrees, b) Outside circumferential linear crack about 21 inches long and spanning 260 degrees.

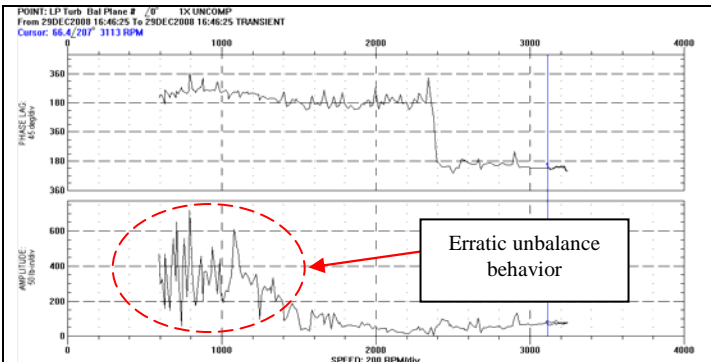
Figure 11: Bode Plot, Rotor Unbalance, LP Turbine Bearing #3 Balance Plane.

The unbalance distributions clearly showed erratic behavior (rapid changes in unbalance distribution) below the first balance resonance of the LP turbine rotor from 1000 rpm to 1600 rpm (compare green dotted circle areas to red dotted circle areas in figures 9 through 15). Since the rotor mass distribution should not change that rapidly, the rotor or bearing stiffness could be changing. Likewise, it is very unlikely that the bearing stiffness would vary in that fashion; therefore rotor stiffness variation (asymmetrical shaft stiffness) would be a probable cause<sup>1</sup>. LP blade loss could cause a rapid change in unbalance distribution; however the change would be a step change in amplitude, phase or both, and change would not vary from run-to-run. The computed unbalance distributions suggested that a shaft crack might be present in the LP rotor based upon vibration measurements and analytical model findings.

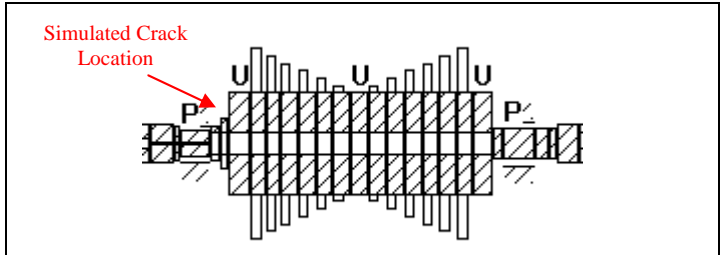
Figure 17: LP Turbine Portion of Rotor Model, Simulated Crack Location Indicated by Red Arrow.

Next, a simulated crack was introduced into the model by reducing the cross section area of the rotor element by 50% near the actual crack location, see figure 17. Rotor model natural frequencies and mode shapes were recomputed with the simulated crack. At 3600 rpm, the mode shape clearly shows that the amplitude at the generator end of the LP rotor is greater than the amplitude at the HP turbine end, figure 18. The effects of the cracked shaft were also evident in the mode shapes at the

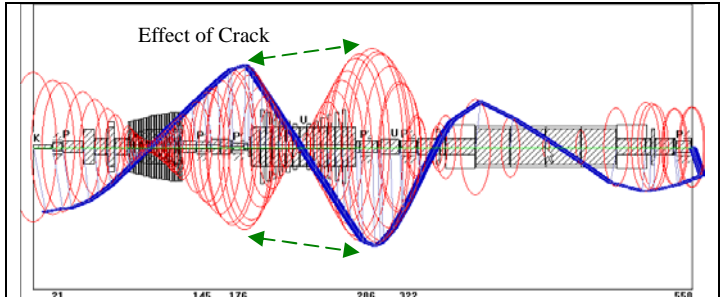
Figure 18: Mode shape at 3600 rpm with simulated shaft crack at HP End of LP Turbine.

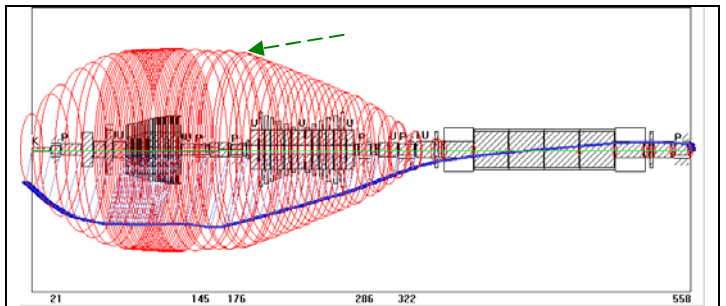
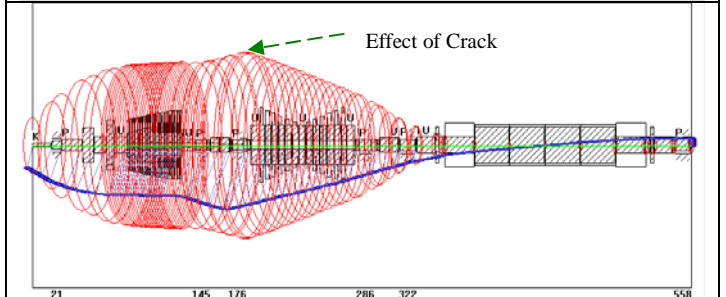
1400 cpm natural frequency, figure 19. A kink in the mode shape is apparent at the crack location.

Figure 19: Mode Shape at 1400 cpm (rpm), Rotor First Natural Frequency, without crack (top), with HP End LP turbine shaft crack (bottom).

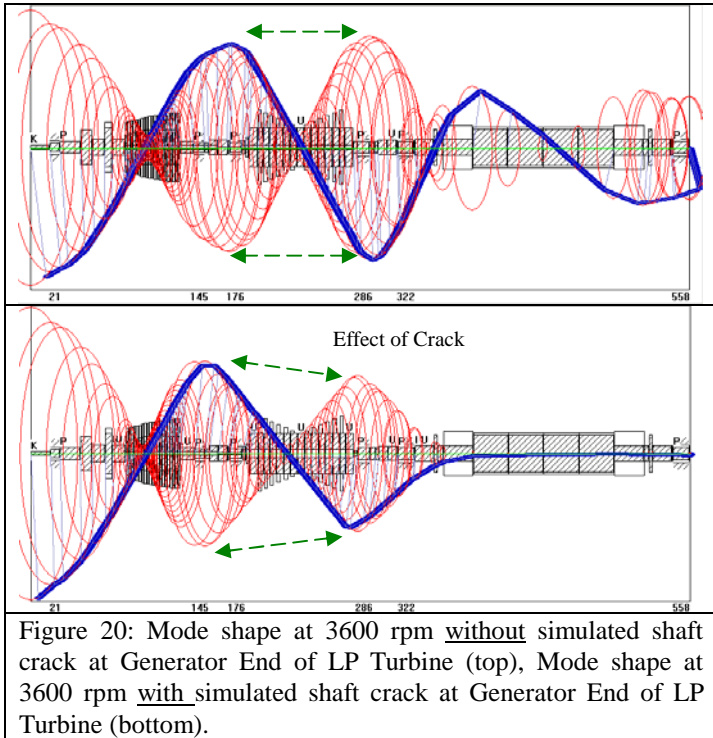
An obvious question would be: Would a similar mode shape change occur if the crack were at the generator end of the LP turbine? A similar crack was also simulated at the other end of the LP rotor, figure 20. The mode shape at 3600 rpm showed

an increase in amplitude at the HP end of the rotor compared to the generator end when the crack was located at the generator end of the rotor. This behavior is generally not intuitively obvious, however the model does explain observed vibration symptoms.

Figure 20: Mode shape at 3600 rpm without simulated shaft crack at Generator End of LP Turbine (top), Mode shape at 3600 rpm with simulated shaft crack at Generator End of LP Turbine (bottom).
