# Case History: Floor Vibration

This case history summarizes an investigation involving excessive vibration levels of the 29<sup>th</sup> floor exercise center of the executive offices of a major corporation. The primary complaint was excessive floor vibration occurring in adjacent executive (CFO) offices and conference rooms during noon lunch time when office staff would use treadmills in the exercise center. Unfortunately, existing vibration isolation pads under each treadmill were not sufficiently reducing floor vibration. All of the floor areas in the exercise center, offices and conference rooms were covered with short nap/pile carpeting. One restriction was no modifications could be made to the carpet or interior office spaces for this investigation, and this investigation was to be conducted at night when the building was empty.

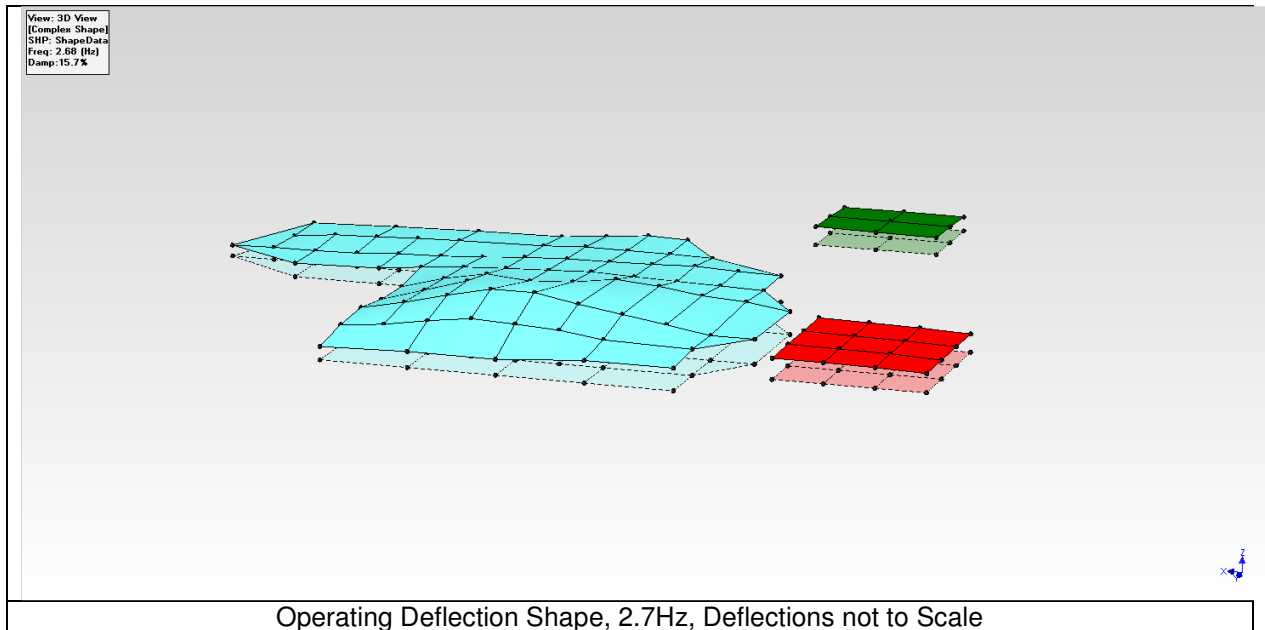
Typical vibration levels adjacent to treadmill #4 (location 17) during normal operation (about 7 mph, foot fall frequency 2.7Hz) were approximately 0.0115 inches peak-to-peak (11.5 mils peak-to-peak). Typical vibration levels in the nearby office (Adjacent to the desk, facing the door) were approximately 7.3 mils peak-to-peak. Operating deflection shape analysis at 2.7 Hz. (treadmill foot-fall frequency) showed a vertical bouncing (trampoline) or membrane motion in the exercise room, office and conference room floors.

The ODS analysis at 2.7Hz suggested that a slight improvement in nearby office and conference room vibration levels could be achieved by relocating some of the treadmills closer to exercise center walls, away from these adjacent rooms. In particular, relocating treadmills adjacent to walls with vertical support beams. Given the constraint of the existing floor structure, locations 13, 14, 25, 26, 41, 42, and 43 appeared to be the best spots for the treadmills (with regards to reducing floor vibration). These locations are closest to vertical structural supports of the building and were farthest from the office and conference rooms. A reduction in office vibration of approximately 38% was measured by relocating these treadmills.

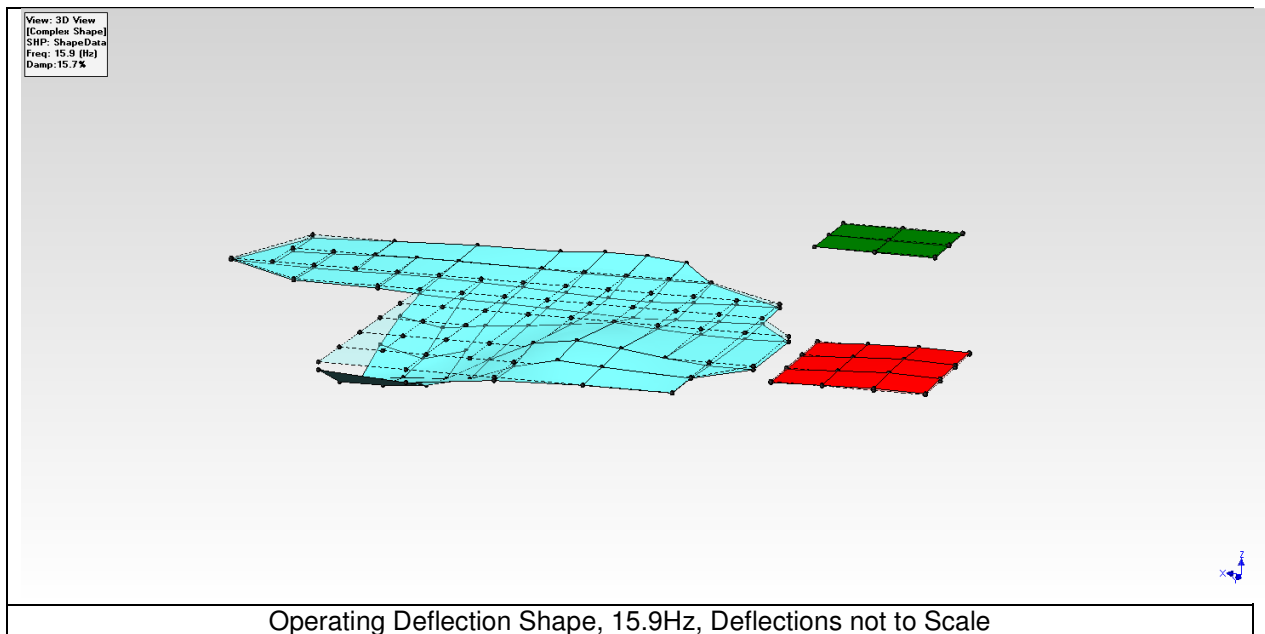
In contrast to the low frequency motion at foot-fall frequency, an additional ODS at 15.9 Hertz was also analyzed. This frequency was selected because the FRF's (Frequency Response Functions) from exercise center floor vibration measurements suggested that a structural resonance might be present. The peak deflections at 15.9Hz were primarily confined to the area surrounding treadmill #4, with very little relative motion occurring in the conference room or nearby office. Therefore, these 15.9Hz deflections were not of immediate concern.
