Power2007-22038

IMPACT OF WIRELESS LASER BASED SHAFT ALIGNMENT ON VIBRATION AND STG COUPLING FAILURE

RoMaDyn Inc.

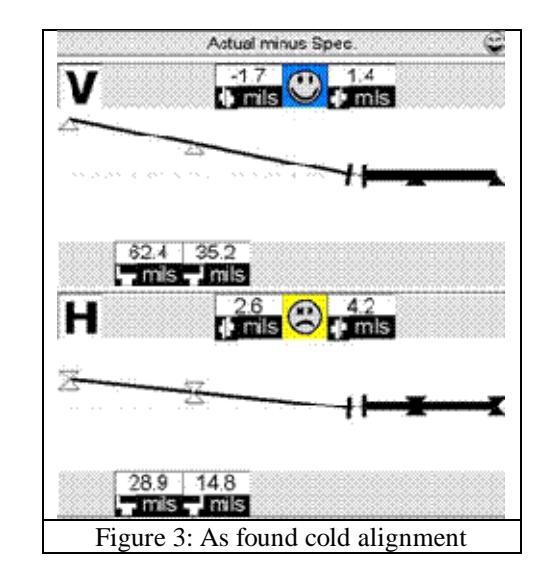
The "as found" vertical and horizontal measured cold alignment for the turbine/gearbox shaft to shaft relationship is shown in figure 3. The turbine shaft is represented to the left, with the pinion shaft fixed on the right. Offsets at the coupling and feet corrections for co-linear alignment are shown in the figure.

The offset numbers represent actual offsets minus any target offsets or thermal growth numbers programmed into the Rotalign system. For this machine, target offsets and thermal growth numbers were set to zero and displayed values represent actual measured coupling offsets. The dashed line projected left of the pinion shaft represents the co-linear alignment position that the machine feet moves on the turbine shaft are measured from this line. A positive foot number represents a shaft position that is high from a co-linear position and needs to move down to achieve a fair or co-linear alignment.

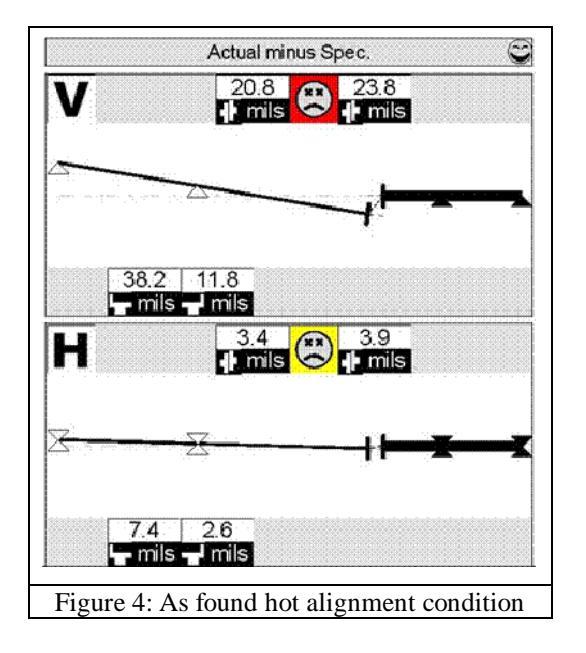
Figure 4 shows the as found hot alignment position between the turbine and pinion and is considered the root cause of the numerous coupling failures. The maximum industry acceptable coupling offset over a 7 inch coupling span at a machine speed of 4150 rpm is 3.4 mils at the 'A' and 'B' flange locations (0.48 mils/inch).

This poor hot alignment condition is the result of thermal growth on the turbine and/or gearbox when the cold shaft to shaft alignment is set close to fair. Although the coupling alignment readings indicate the relative amount of thermal movement between the two shafts, they do not resolve how much each shaft or casing is moving relative to the foundation or frame. In order to determine the amount of casing or shaft absolute thermal growth, the turbine and pinion were instrumented with proximity probes mounted on water cooled stands viewing the bearing housings relative to the unit frame. This data is shown below in Figure 5.

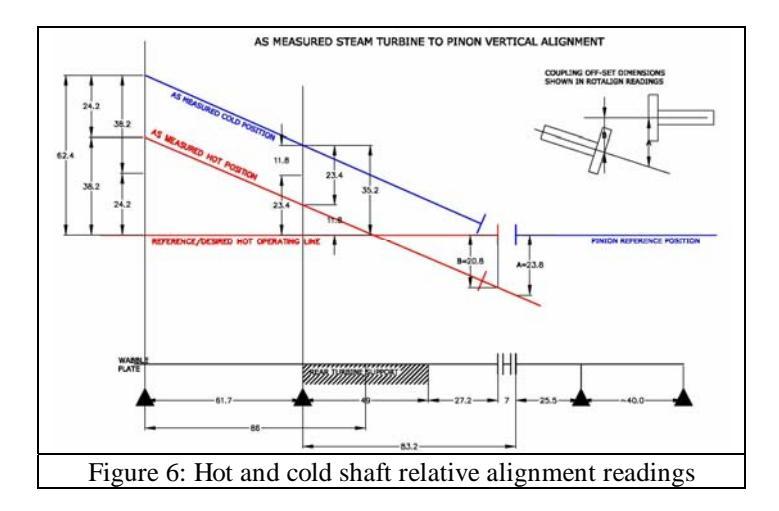
Figure 6 below displays the relative vertical hot and cold shaft positions acquired from the hot and cold alignment checks. This data shows a relative (to the pinion) turbine shaft drop of approximately 24 mils from cold to hot operating conditions at both ends of the turbine. Remembering that these are relative shaft to shaft positions and some of the turbine drop is accounted for by gearbox rise.

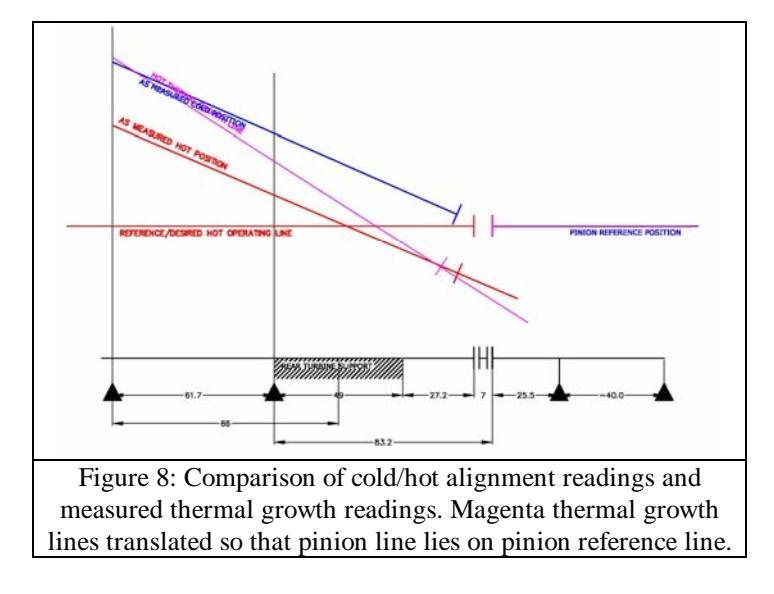
This verification is accomplished by translating the magenta turbine and pinion hot thermal growth lines down relative to each other so that the magenta pinion line lies on the blue pinion reference line. The magenta turbine line is then compared to the red "*as measured hot position*" turbine line to ensure that they are close to the same. This is shown in Figure 8 below.

There is an obvious angular difference in the two lines; however, the coupling offset differences measure to within 4 mils indicating fairly good agreement between the cold/hot alignment readings and the thermal growth readings.

The angular difference in the turbine lines may be accounted for in some part by the fact that thermal growth readings of the pinion blind end bearing were not available to correct these readings. The assumption was uniform thermal growth on both ends of the gearbox. If there was any differential thermal growth in the pinion bearings, this would induce some angularity in the pinion thermal growth line, affecting the translated position of the turbine line. In order for the turbine line to be closer to the red as measured hot position, the pinion blind end would need to have slightly less thermal growth than the drive end, opening the angle between the turbine/pinion magenta lines.

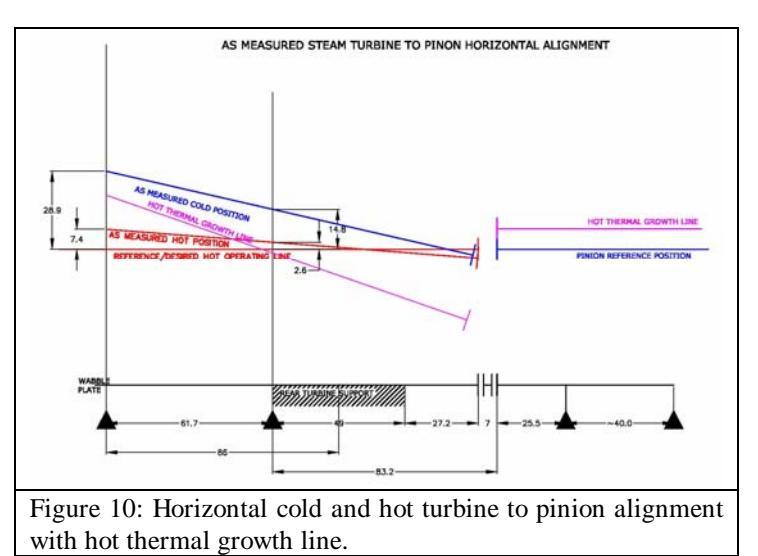
Figure 10 above adds in the horizontal thermal growth line in magenta. As can be seen, the thermal growth line is further out of tolerance than the hot alignment readings. The bracket holding the thermal growth proximity transducers was water cooled in the main stand pipe that controlled vertical growth very closely; however, although the horizontal support arms on the coupling stand were water drip cooled as best as possible, it is believed that thermal expansion of this angle iron accounts for much of the difference in the laser alignment readings and the horizontal thermal growth data. The smaller differences in the readings at the turbine inlet are likely accounted for by the much shorter bracket lengths at this location. The hot and cold laser alignment readings are believed to better represent the horizontal alignment condition and will be used to determine the desired cold alignment settings.

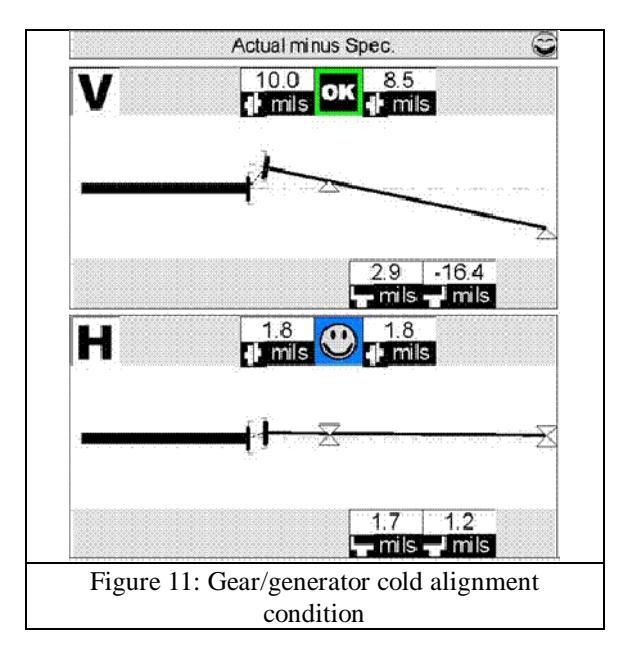
The as found vertical and horizontal cold alignment condition between the gearbox and the generator is shown in Figure 11. The gearbox gear shaft is represented as the fixed reference shaft with the generator shaft to the right. The 10.375 inch coupling span on an 1800 rpm shaft accommodates larger offsets and the as found cold alignment was within the acceptable tolerance range.

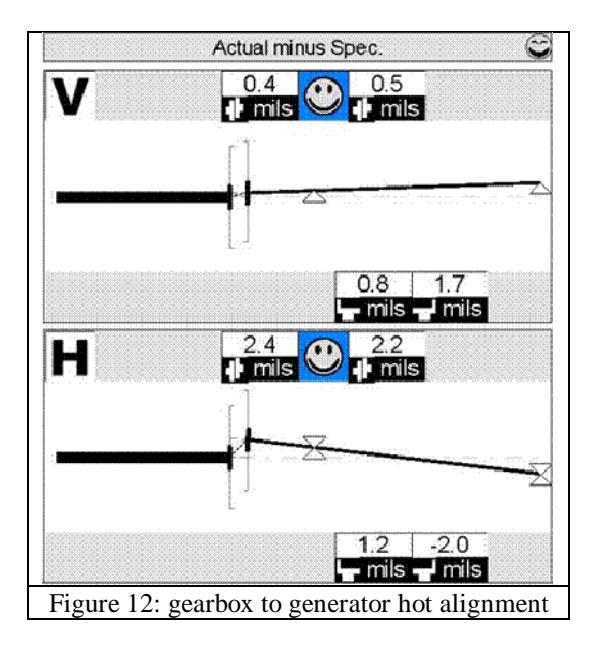
The as found hot alignment condition between the gearbox and the generator is shown in Figure 12 below. Gearbox and/or generator growth has improved the hot alignment condition; however, as will be shown in the Alignment Targets section below, both the gearbox and generator would likely need vertical shim moves in order to achieve the correct turbine to gearbox hot alignment.

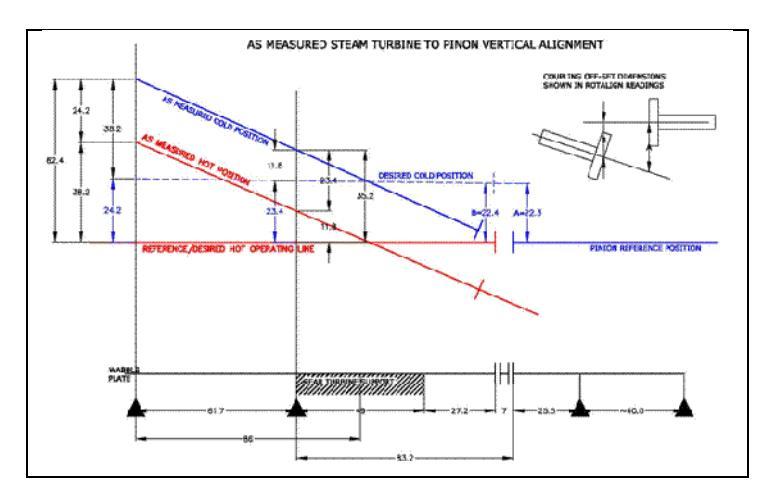
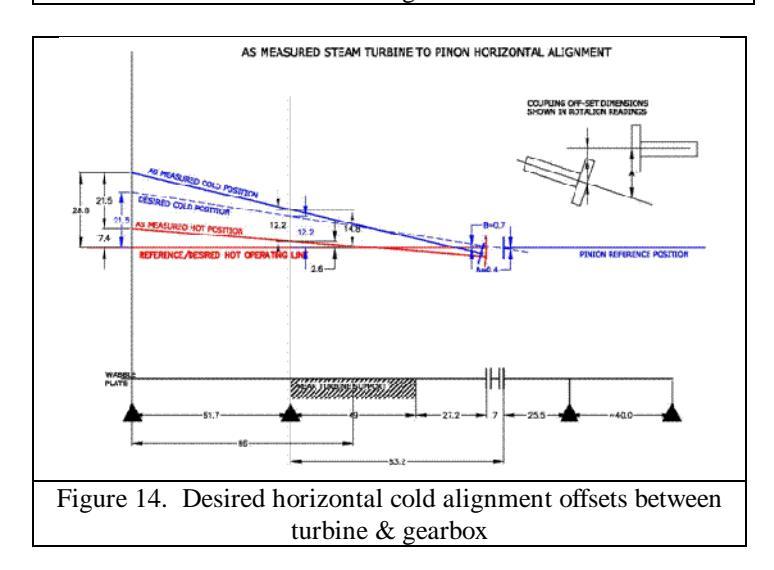
Figure 13. Desired vertical cold alignment offsets between

The turbine to gearbox drawing vertical offset numbers did not incorporate the 3-5 mil turbine/pinion difference in shaft rise.

Including this into the coupling offsets adjusts the 'A' and 'B' offset targets to 26 mils.

During August, the recommended procedure for the realignment of the unit was to first raise the gearbox and *precision level it* and dowel pin or re-dowel pin it to the foundation in one location under the pinion drive end prior to beginning alignment moves on the turbine then generator casings. In addition, the OEM recommendations on gearbox dowel pin procedures for proper pinning should be followed.

It was also recommended that additionally care should be taken to measure and remove all soft foot conditions from the gearbox prior to beginning turbine or generator alignment. The maximum allowable soft foot should be less than 1 mil.

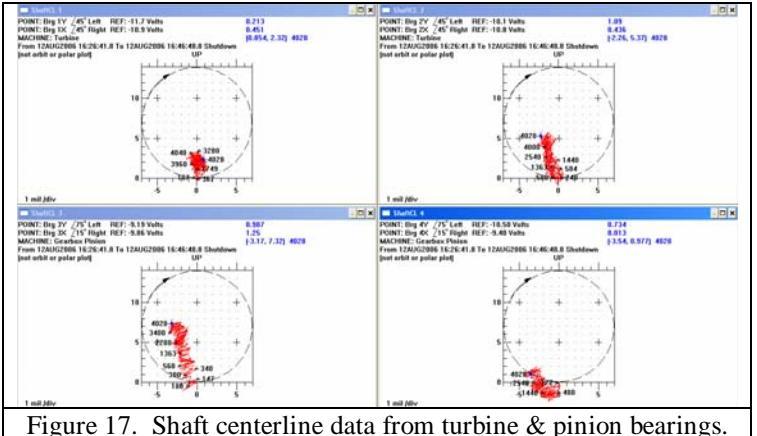
Analysis of the shaft centerline and orbit data supported the alignment findings of hot misalignment between the turbine and pinion bearings. Prior to alignment measurements, shaft centerline data shown below in Figure 17 indicated bearings #1 and #4 (turbine inlet & pinion blind end) were supporting the predominate load of the turbine/pinion coupled shaft.

The inlet turbine bearing operating position was abnormally low in the bearing clearance typical of heavy journal loading.

The differential rise position at steady state full load rpm of the pinion drive end and blind end by 4 - 6 mils was indicative of very poor alignment in this double helical set.

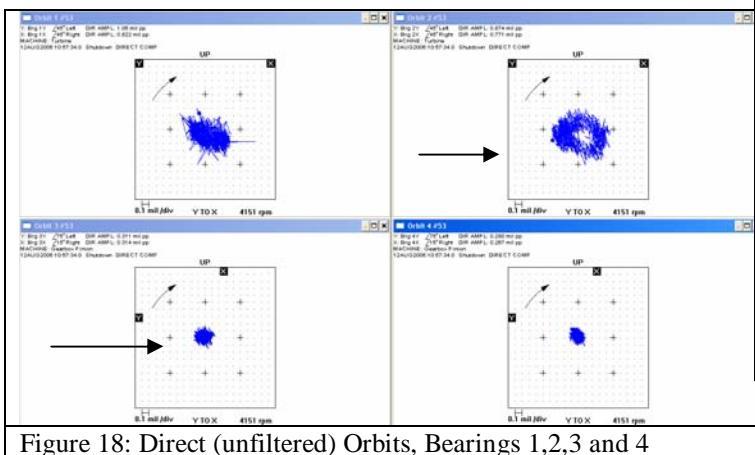
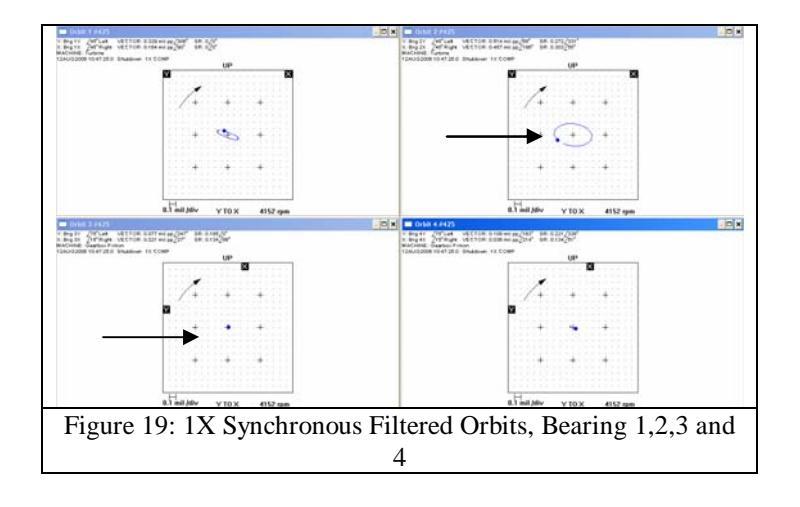
Shaft relative orbits showed indications that bearing load was not evenly distributed. The orbits of bearings 2, 3 and 4 were open and elliptical, see figure 18. They were also

predominately forward precessed, see figure 19. Vibration amplitudes and orbit shapes at bearing 2 and 3 were not similar on either side of the coupling.

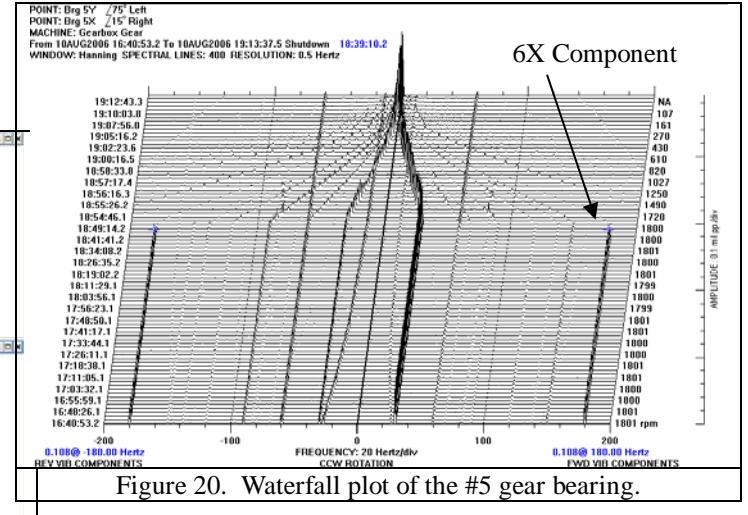
Waterfall data shown below in Figure 20 from the gear at bearings 5 and 6 showed a 6X gear frequency component that might be indicative of tooth wear that should be verified during a future outage. This vibration component drops out during coast down when generator initeria back drives the gear set and gear teeth are engaged on the opposite faces. A recommendation was made to open and inspect the gear and pinion for wear indications during the next outage. A blue check of the teeth was also recommended.

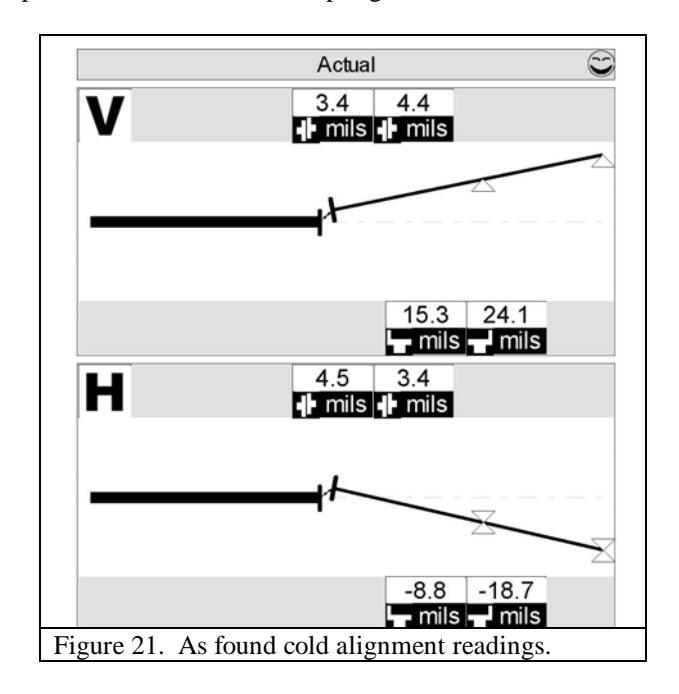
The as found vertical and horizontal measured cold alignment for the turbine/gearbox shaft to shaft relationship is shown in Figure 21. The turbine shaft is represented to the right, with the pinion shaft fixed on the left. Offsets at the coupling and feet corrections for co-linear alignment are shown in the figure. This cold alignment position differed from the readings taken in August by a considerable amount, with these readings showing the turbine lower 42 mils at the front feet and 20 mils at the rear feet than those taken in August. The difference in the cold readings was determined to be the result of temperature differences in the turbine front wobble feet at the time of the readings with these readings colder than those in August and very near ambient (91°F at the turbine mount interface) after 48 hours. The August "cold" readings were taken 24 hours after shutdown.

The offset numbers represent actual offsets without any target offsets or thermal growth numbers programmed into the Rotalign® system. For this project targets offsets and thermal growth numbers were set to zero and displayed values represent actual measured coupling offsets.

The dashed line projected right of the pinion shaft represents the co-linear alignment position that the machine feet moves on the turbine shaft are measured from. A positive foot number represents a shaft position that is high from a co-linear position and needs to move down to achieve a fair or co-linear alignment.

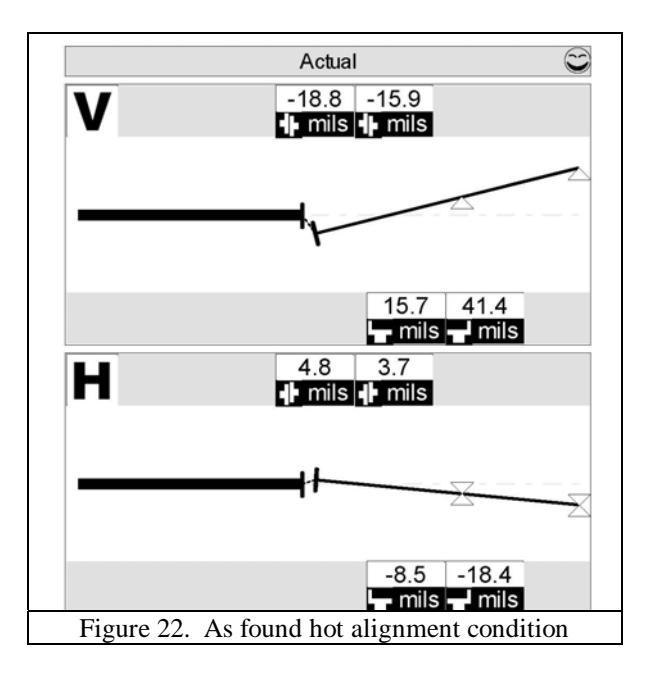
Figure 22 shows the as found hot alignment position between the turbine and pinion. The maximum industry acceptable coupling offset over a 7 inch coupling span at a machine speed of 4150 rpm is 3.4 mils at the 'A' and 'B' flange locations (0.48 mils/inch) for a 'good' alignment condition.

This poor hot alignment condition is the result of thermal growth on the turbine and/or gearbox when the cold shaft to shaft alignment is set close to fair.

These 'as found' November cold and hot alignment positions were used to determine the final shim corrections needed to the turbine to achieve a hot co-linear alignment condition.

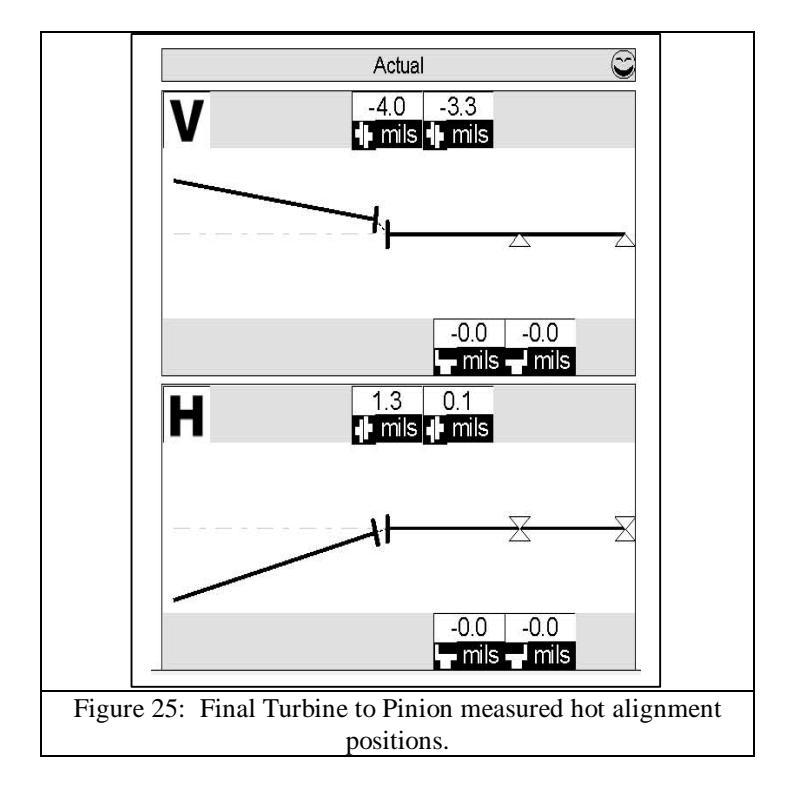
The final hot alignment condition between the turbine and gearbox was considered good for the 7 inch span Form Flex spacer coupling. Off-sets at the coupling measured within 15 minutes of unit stop from a thermally stable 18 MW load run were 3.3 and 4.0 mils for the 'A' and 'B' measurements as shown in the hot rotor position drawing in Figure 25 below The turbine shaft is represented as the moveable machine to the right with the pinion to the left.

Industry recommendations for the upper limit of an acceptable alignment condition for a machine speed of 4150 rpm would be an offset *no larger* than 1 mil per inch of coupling span, or a total of 7 mils offset for this Form Flex coupling.

The final vertical alignment moves on the turbine were as follows:

Remove 20 mils of existing shims from the turbine front wobble feet. Net total of 12 mils installed.

Add 10 mils to the turbine rear support. Net total of 10 mils installed.

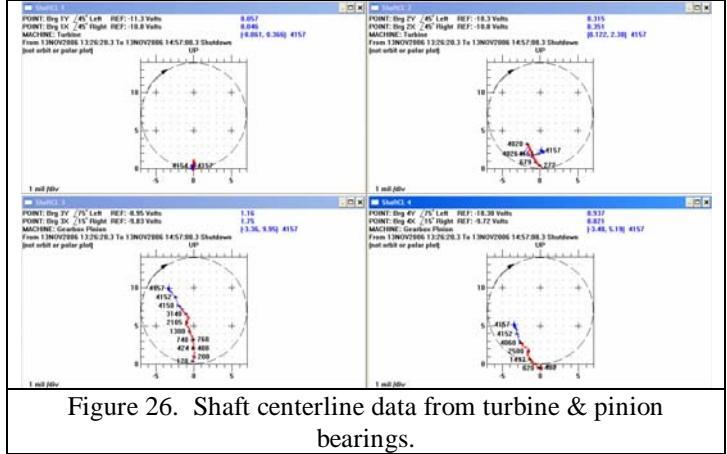
Oddly, shaft centerline and orbit data indicated little change between the August and November post alignment, see figure 26. Although amplitudes were lower, orbits on the turbine were still somewhat flattened and shaft centerline positions for both the turbine and pinion are very similar to the August data. Shaft centerline data still indicated the front turbine bearing to be heavily loaded and very low in the bearing clearance with the pinion blind end bearing lower than the drive end. Although the relative shaft to shaft alignment between the turbine and pinion now appears to be in good condition during operation conditions, the shaft centerline positions indicate the #1 and #4 bearing still to be carrying the predominate turbine/pinion rotor load. Turbine bearing loading may be more a function of the turbine rotor mass distribution than relative bearing alignment conditions.

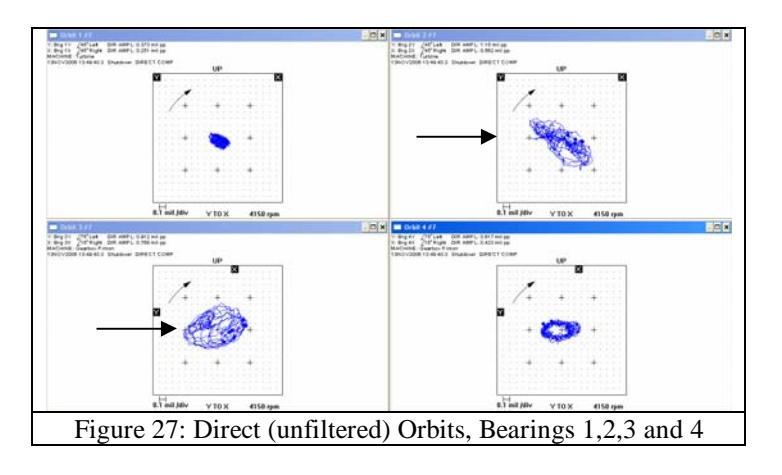
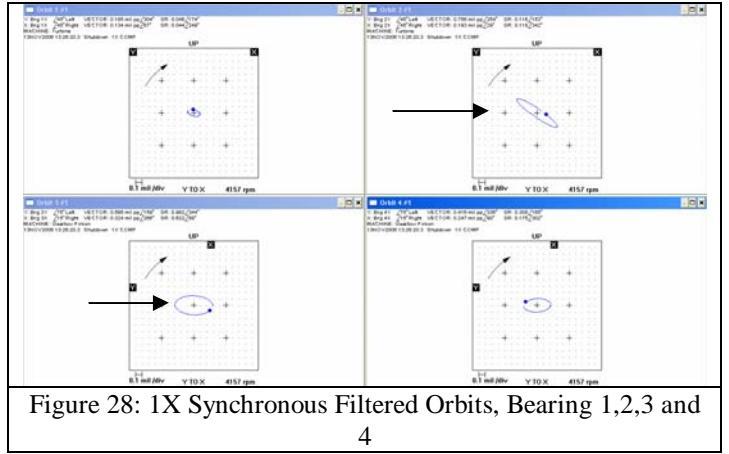
Shaft relative orbits showed indications that bearing load was more evenly distributed. The orbits of bearings 2, 3 and 4 were open and elliptical, see figure 27. The orbits were also predominately forward precessed, see figure 28. Vibration amplitudes at bearing 2 and 3 were also very similar on either side of the coupling.

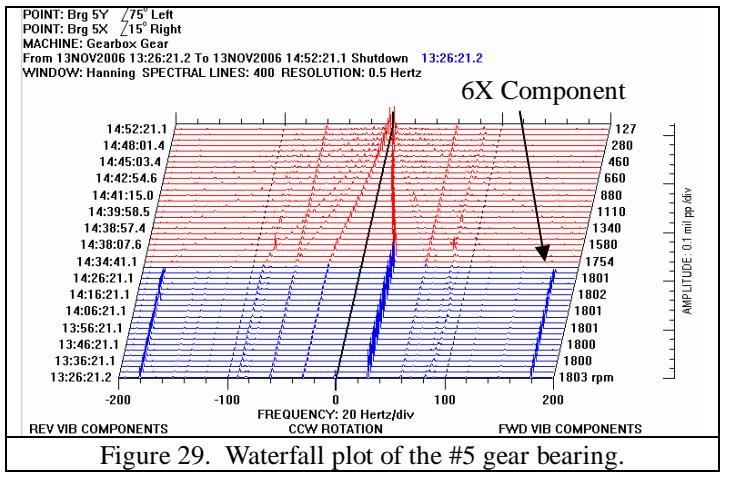
Waterfall data from the gear bearings still showed a 6X gear frequency component that may be indicative of tooth wear that should be verified during the next outage, see figure 29. The component drops out during coast down when generator inertia back drives the gear set and gear teeth are engaged on the opposite faces.

In addition to the alignment corrections, recommendations were made to open and inspect the gear and pinion for wear indications during the next outage. A blue check of the teeth was recommended.
