PVP2011-57017

## ACOUSTIC AND VIBRATION ANALYSIS OF FLUID INDUCED BLOWER AND PIPING UNWANTED MOTION

Ned M. Endres, Senior MDS Representative  
Metrix Instruments Corporation

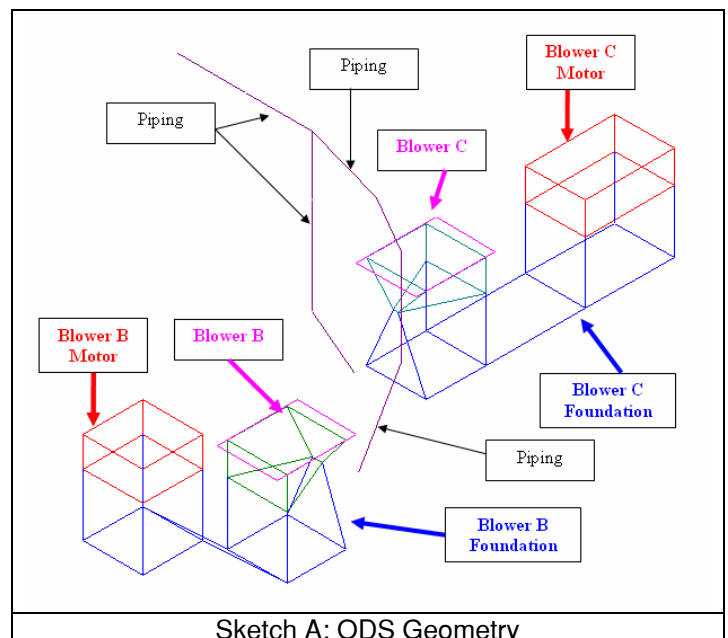
Sketch A: ODS Geometry

To visualize the ODS deflections, a computer “model” of the geometry of the measured points was generated; see sketch A and B. ODS deflections for each measured location were applied to matching points in the computer model. Since the ODS deflections are very small compared to the dimensions on the machine, the amplitudes of the ODS are scaled and animated so that the motion was clearly visible on the computer screen. In other words, the ODS deflections in the model are greatly exaggerated to make them visually apparent; in short, the deflections are not display at the scale of the models itself. Hence, an ODS shows the relative motion and phase between locations on the blower components, not absolute “scaled” deflections of the machine. In the ODS figures, the black dotted lines are the undeformed ODS model shape. The solid lines are the animated ODS shape.

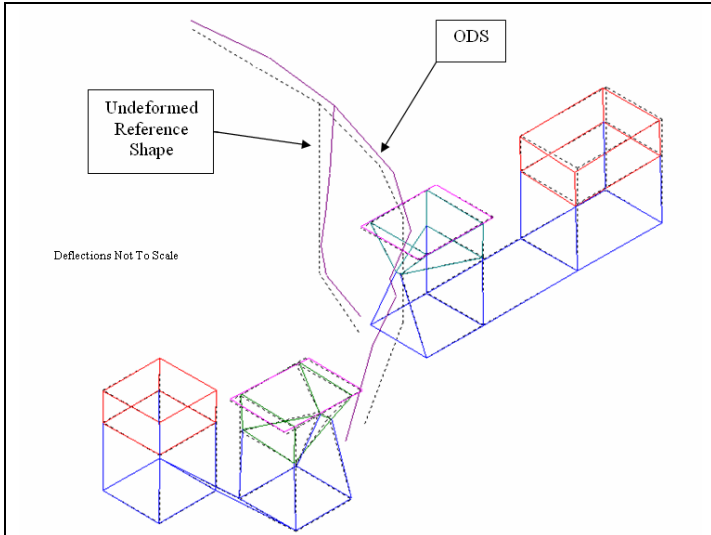
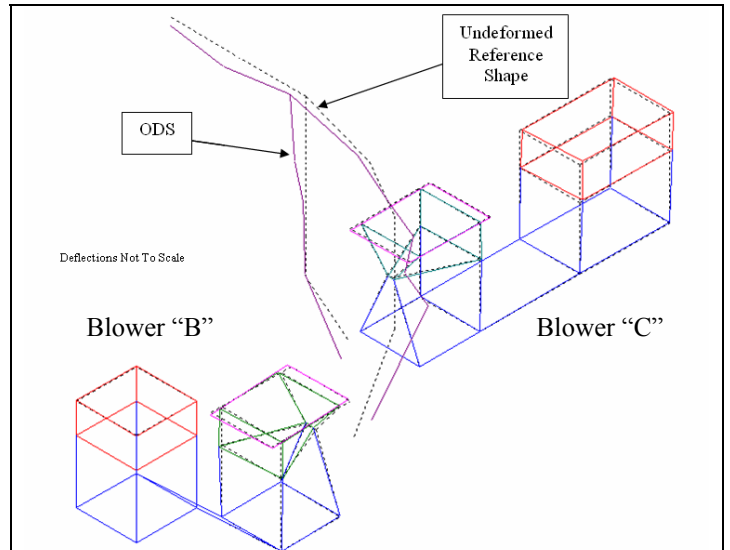
The operating deflection shape was assembled from vibration measurements acquired for 70 vibration measurement locations. Figures 7 through 14 illustrate the operating deflection shape at 60Hz, the frequency corresponding to the fundamental tone. This ODS shape clearly showed significant deflections occurring at piping sensor locations 9, 10, 19 through 28, and 65 with the motion being predominately vertically in the Z direction and axially in the X direction. This motion appears to be in reaction to pressure pulsations from the two running blowers; however dynamic pressure measurements would have to be performed to confirm this hypothesis. To arrest the piping motion, the piping could be constrained by pipe fixturing (snubber, pipe rolls, spring hangers...) or a tuned damper; however it was believed that these actions would probably not reduce noise levels appreciably. This solution would help reduce piping vibration, cracks and other potential fatigue damage (photo 4). The ODS also showed blowers B

and C moving slightly vertically up and down (out-of-phase with each other) in what appears to be reaction to the exhaust pulsations at 3600 cpm and piping motion. Coherence measurements between blower and piping vibration showed good correlation ( $> 0.7$ ) between blower and piping vibration at 3600 cpm. Sound measurements and blower vibration also showed good correlation ( $> 0.7$ ) at 3600 cpm. These coherence levels ( $> 0.7$ ) indicate a reasonable “cause and effect” relationship between sound and blower vibration and between piping and blower vibration (figure 15).

Figure 7: Operating Deflection Shape at 3600 cpm  
Isometric View

Figure 10: Operating Deflection Shape at 3600 cpm  
Axial View

Figure 8: Operating Deflection Shape at 3600 cpm  
Top View

Figure 11: Operating Deflection Shape at 3600 cpm  
Isometric View

Figure 9: Operating Deflection Shape at 3600 cpm  
Lateral View (side view)

Figure 12: Operating Deflection Shape at 3600 cpm  
Top View

Figure 13: Operating Deflection Shape at 3600 cpm Lateral View (side view)

Figure 14: Operating Deflection Shape at 3600 cpm Axial View

In late March, the best initial solution to both the vibration and noise problems appeared to be installing exhaust silencers on each blower. It was anticipated that reduced exhaust pulsation should occur which should also reduce piping vibration and exhaust generated noise. An acoustic standing wave due to blower exhaust pulsations appeared to be the root cause, but dynamic pressure measurements would be needed to confirm this conclusion.

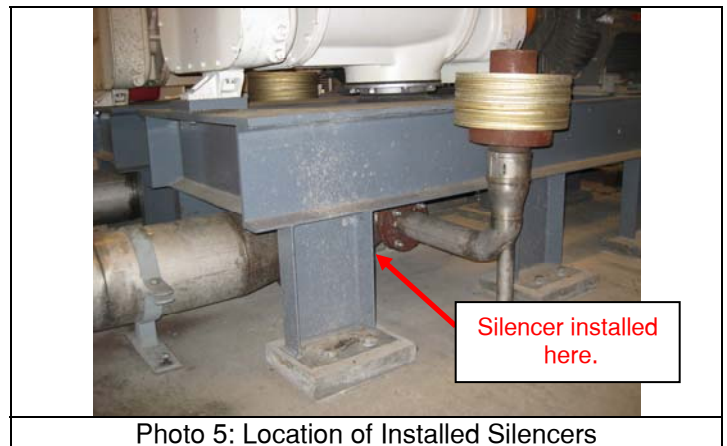
Photo 5: Location of Installed Silencers

Exhaust silencers were installed on each blower in April 2010, see photo 5. They had an immediate effect on sound pressure levels both inside the blower room and in the surrounding neighborhood. Sound pressure levels dropped at least 20dBA inside and outside of the blower room, making for a more pleasant environment for maintenance personnel. In-house PdM vibration measurements revealed that blower vibration levels were reduced by more than 50%.

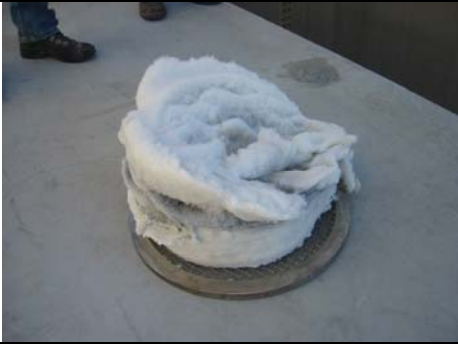
In July 2010, Blower C experienced problems with silencer packing material escaping without any detectable mechanical

damage to the silencer or its welds; see photos 6 and 7. Fortunately, this packing material was captured by a down stream screen. The silencer OEM is pursuing a root cause for the packing material issue and has deployed a differently designed silencer. Dynamic pressure measurements were recommended as further testing to be conducted during a future outage in order to measure pressure intensity of the acoustic standing wave and to provide insight into silencer packing issues.

Photo 6: Silencer packing material retrieved from downstream screens prior to aeration tank

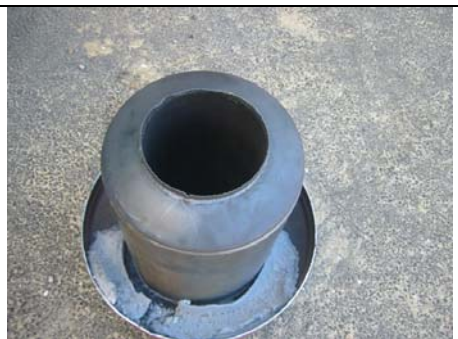
Photo 7: Disassembled silencer showing loss of packing material without physical damage to silencer
