Power2007-22038

IMPACT OF WIRELESS LASER BASED SHAFT ALIGNMENT ON VIBRATION AND STG COUPLING FAILURE

RoMaDyn Inc.

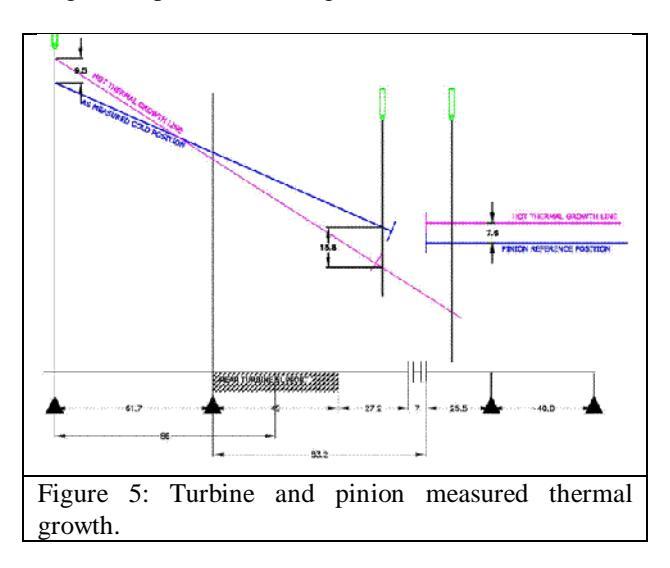
To ensure accurate thermal growth readings of the steam turbine, proximity probes mounted on water cooled stands were set up viewing the turbine inlet bearing, turbine exhaust bearing and pinion drive end bearing housings. The probes documented casing movement in the X and Y growth directions from the shaft centerline at the turbine exhaust and pinion drive ends and movement in the X, Y and Z (axial) directions at the turbine inlet end at the left support foot (viewed turbine to generator). Photos 1 and 2 below show the transducer arrangements. Photo 3 shows the alignment equipment setup. Figure 5 below displays the data acquired from these measurements transferred into the as found cold alignment position drawing.

The blue lines represent the cold relative vertical shaft positions from the cold alignment check. The magenta lines represent the turbine and pinion shaft position changes based on the thermal growth measurements of a 9.5 mils rise at the turbine inlet end, a 15.8 mil decrease at the turbine exhaust end and a 7.6 mil rise of the pinion drive end bearing.

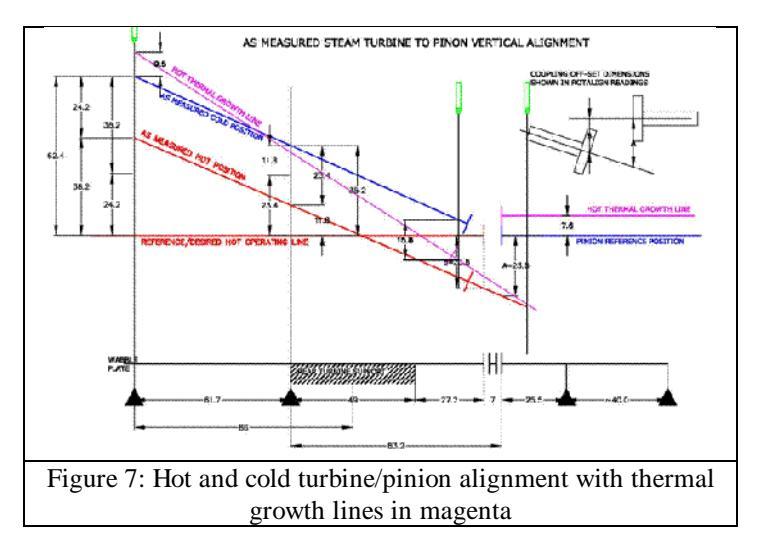
This hot/cold alignment data is now combined with the thermal growth data in Figure 7 below to verify the hot laser

alignment readings are close to actual and have not been affected by unit cooling or process load changes.

This verification is accomplished by translating the magenta turbine and pinion hot thermal growth lines down relative to each other so that the magenta pinion line lies on the blue pinion reference line. The magenta turbine line is then compared to the red "*as measured hot position*" turbine line to ensure that they are close to the same. This is shown in Figure 8 below.

There is an obvious angular difference in the two lines; however, the coupling offset differences measure to within 4 mils indicating fairly good agreement between the cold/hot alignment readings and the thermal growth readings.

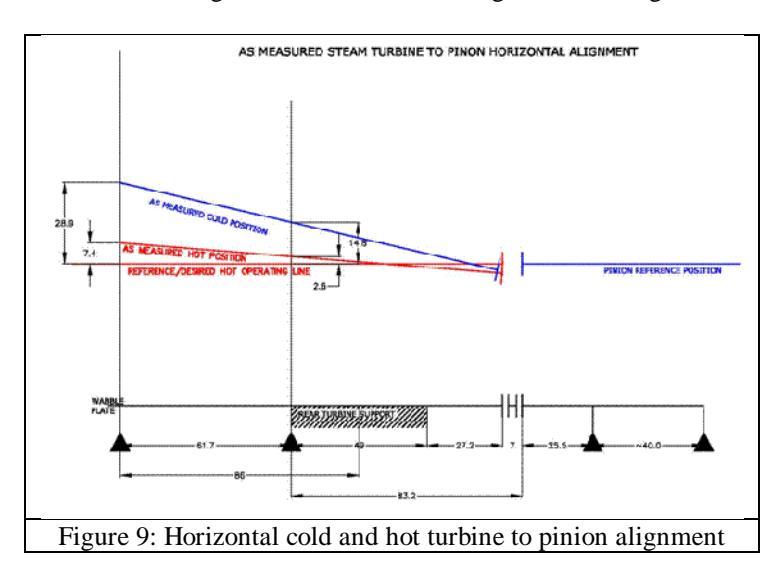
Although outside of the recommended alignment tolerances as shown above in Figure 2, the turbine to pinion cold and hot horizontal alignment was much closer than the vertical alignment. The thermal growth at both turbine bearings and the pinion drive end was recorded as 20 mils to the left at the turbine inlet, 1.4 mils to the right at the turbine exhaust and 7.6 mils to the left at the pinion drive end. Figure 9 documents the cold to hot thermal growth changes between the turbine and gear based on the laser alignment readings.

Figure 10 above adds in the horizontal thermal growth line in magenta. As can be seen, the thermal growth line is further out of tolerance than the hot alignment readings. The bracket holding the thermal growth proximity transducers was water cooled in the main stand pipe that controlled vertical growth very closely; however, although the horizontal support arms on the coupling stand were water drip cooled as best as possible, it is believed that thermal expansion of this angle iron accounts for much of the difference in the laser alignment readings and the horizontal thermal growth data. The smaller differences in the readings at the turbine inlet are likely accounted for by the much shorter bracket lengths at this location. The hot and cold laser alignment readings are believed to better represent the horizontal alignment condition and will be used to determine the desired cold alignment settings.

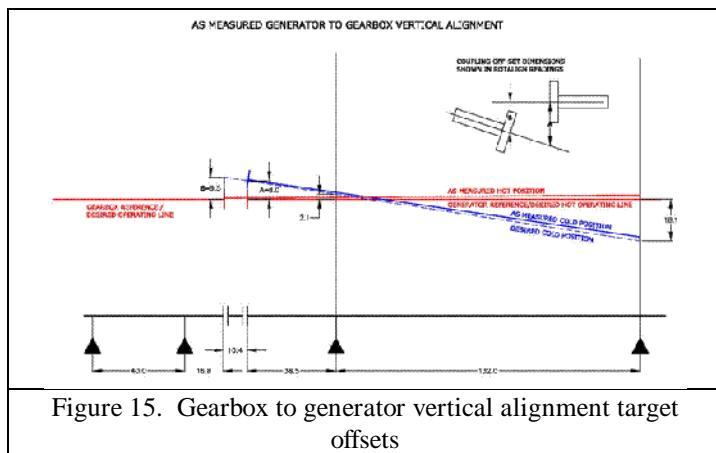
Figure 13. Desired vertical cold alignment offsets between

The turbine to gearbox drawing vertical offset numbers did not incorporate the 3-5 mil turbine/pinion difference in shaft rise.

Including this into the coupling offsets adjusts the 'A' and 'B' offset targets to 26 mils.

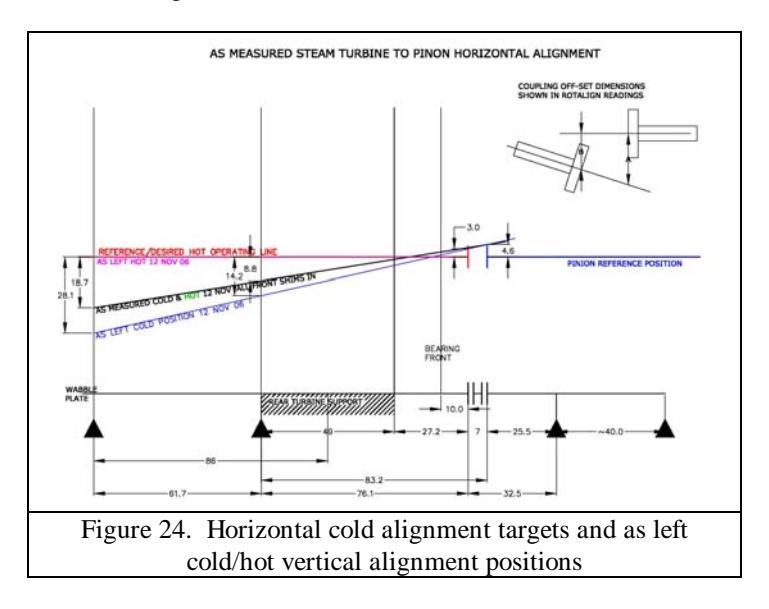
Horizontal cold to hot movement on the turbine is not well understood as there was very little as found cold to hot horizontal movement as seen in Figures 19 and 20; however, there appeared to be a significant change between the cold/hot horizontal positions after the final vertical alignment moves as shown in Figure 22 below.

The final hot horizontal alignment condition appeared very good with 1.3 mils off-set at the B coupling location the largest off-set. As the wobble feet are both pinned and the rear turbine supports are keyed in the horizontal and axial directions, there was no attempt to change the turbine horizontal alignment position.
