## Power2009-81019

### IDENTIFICATION OF ABNORMAL ROTOR DYNAMIC STIFFNESS USING MEASURED VIBRATION INFORMATION AND ANALYTICAL MODELING

Ned M. Endres, Principal MDS Specialist

RoMaDyn Corporation

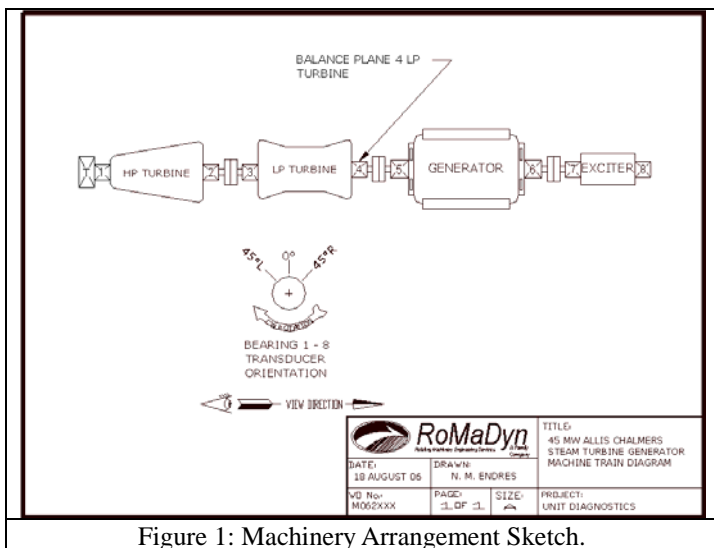
Figure 1: Machinery Arrangement Sketch.

This 45 MW steam turbine was driving a 2-pole 3600 rpm generator. As shown on the Machinery Arrangement Sketch (figure 1), the unit was equipped with X-Y shaft-relative proximity probes on all bearings. The unit was also equipped with a thrust probe at turbine bearing #1.

Throughout this paper, Bently Nevada naming conventions for probe orientations will be used. The Y proximity probe (45L) will be referred to as the “vertical” probe and the X proximity probe (45R) will be referred to as the “horizontal” probe, as viewing the unit from the turbine thrust bearing towards the generator non-driven end bearing, see figure 1 below.

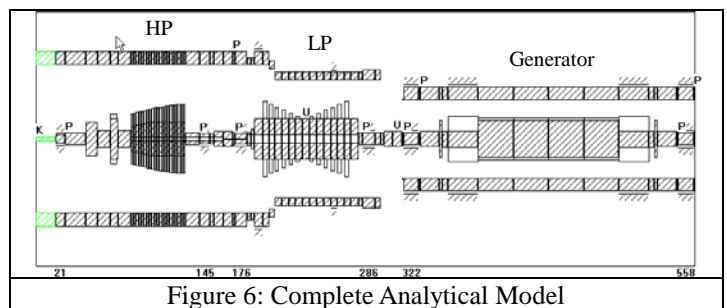
Figure 6: Complete Analytical Model

Proximity probe (P) points are inserted into the model at locations where measured vibration data is available (and imported into the model) or at locations where shaft relative deflections are to be calculated. Unbalance (U) can be included at prescribed points and circumferential angles. A once-per-revolution speed reference (K) point can also be included, see figure 6.

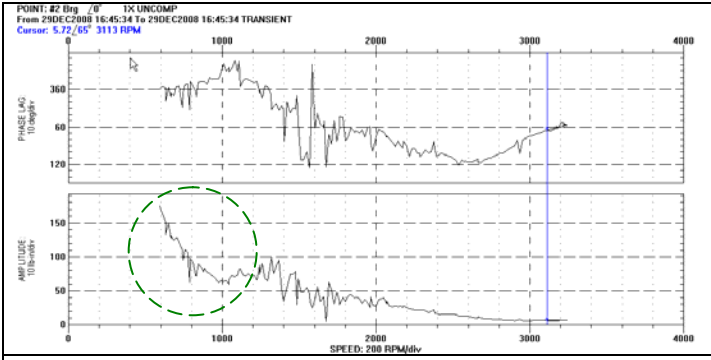
Figure 10: Bode Plot, Rotor Unbalance, HP Turbine Bearing #2 Balance Plane.

The unbalance distributions clearly showed erratic behavior (rapid changes in unbalance distribution) below the first balance resonance of the LP turbine rotor from 1000 rpm to 1600 rpm (compare green dotted circle areas to red dotted circle areas in figures 9 through 15). Since the rotor mass distribution should not change that rapidly, the rotor or bearing stiffness could be changing. Likewise, it is very unlikely that the bearing stiffness would vary in that fashion; therefore rotor stiffness variation (asymmetrical shaft stiffness) would be a probable cause<sup>1</sup>. LP blade loss could cause a rapid change in unbalance distribution; however the change would be a step change in amplitude, phase or both, and change would not vary from run-to-run. The computed unbalance distributions suggested that a shaft crack might be present in the LP rotor based upon vibration measurements and analytical model findings.

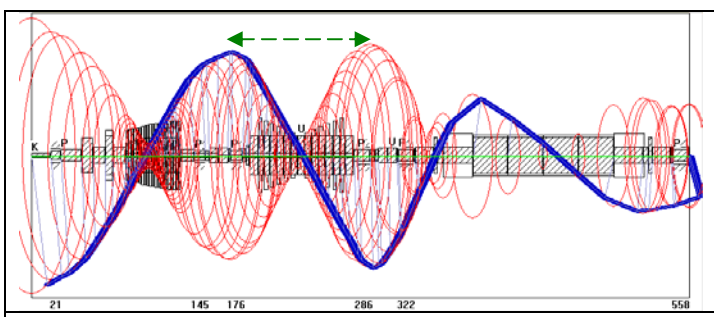
Figure 16: Mode shape at 3600 rpm without simulated shaft crack.

The rotor dynamics model provides an answer to this question. Effects of a shaft crack near bearing #3 can be simulated using the rotor model. Natural frequencies and mode shapes of the rotor were computed with and without a crack present at approximately the location of the actual crack. Simulating a crack means reducing the diameter of rotor elements at the crack location, thereby reducing the bending stiffness of the shaft. Without the crack, amplitudes of the rotor mode shape at 3600 rpm were approximately equal at both ends of the LP turbine, see figure 16.

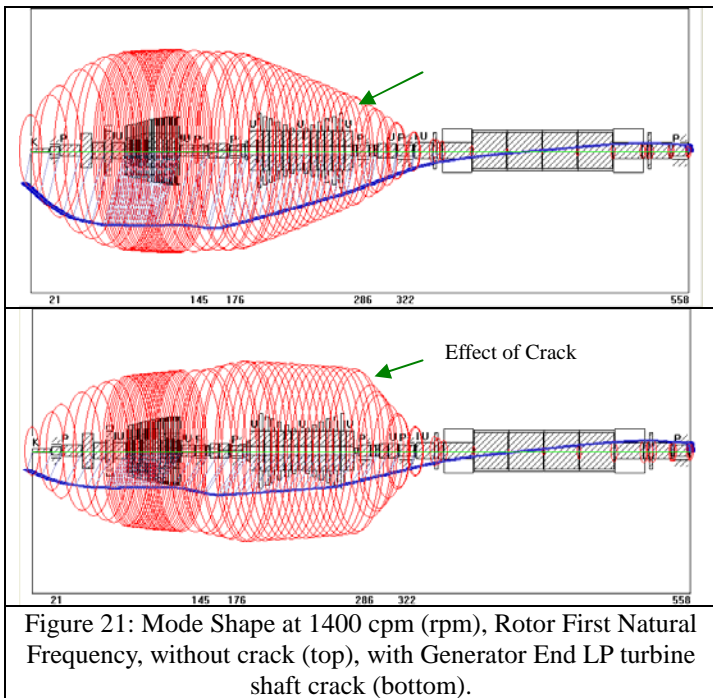
Figure 21: Mode Shape at 1400 cpm (rpm), Rotor First Natural Frequency, without crack (top), with Generator End LP turbine shaft crack (bottom).

An obvious question would be: Would a similar mode shape change occur if the crack were at the generator end of the LP turbine? A similar crack was also simulated at the other end of the LP rotor, figure 20. The mode shape at 3600 rpm showed

an increase in amplitude at the HP end of the rotor compared to the generator end when the crack was located at the generator end of the rotor. This behavior is generally not intuitively obvious, however the model does explain observed vibration symptoms.
