# Case History: Floor Vibration

This case history summarizes an investigation involving excessive vibration levels of the 29<sup>th</sup> floor exercise center of the executive offices of a major corporation. The primary complaint was excessive floor vibration occurring in adjacent executive (CFO) offices and conference rooms during noon lunch time when office staff would use treadmills in the exercise center. Unfortunately, existing vibration isolation pads under each treadmill were not sufficiently reducing floor vibration. All of the floor areas in the exercise center, offices and conference rooms were covered with short nap/pile carpeting. One restriction was no modifications could be made to the carpet or interior office spaces for this investigation, and this investigation was to be conducted at night when the building was empty.

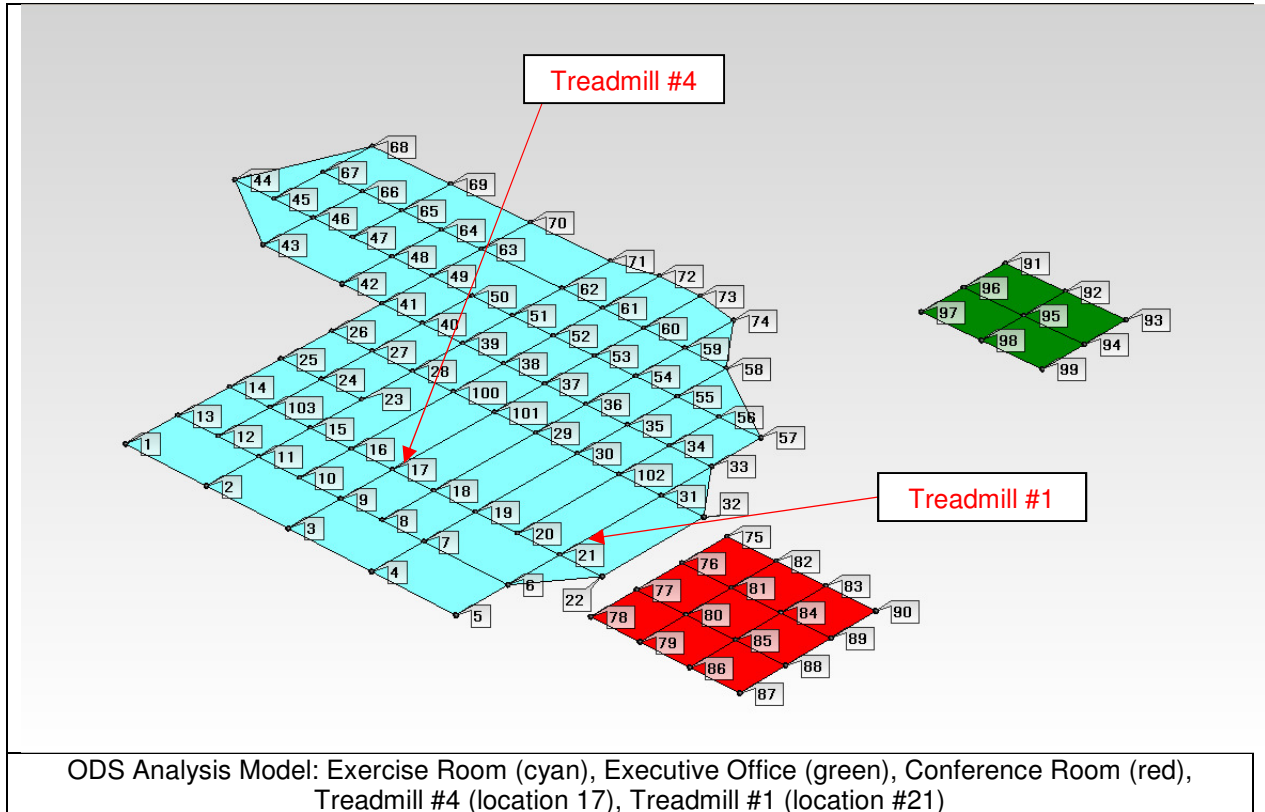
Typical vibration levels adjacent to treadmill #4 (location 17) during normal operation (about 7 mph, foot fall frequency 2.7Hz) were approximately 0.0115 inches peak-to-peak (11.5 mils peak-to-peak). Typical vibration levels in the nearby office (Adjacent to the desk, facing the door) were approximately 7.3 mils peak-to-peak. Operating deflection shape analysis at 2.7 Hz. (treadmill foot-fall frequency) showed a vertical bouncing (trampoline) or membrane motion in the exercise room, office and conference room floors.

Vibration levels in the nearby office dropped to approximately 5.4 mils peak-to-peak when treadmill #1 (treadmill closest to the wall, location 21) was in operation instead of treadmill #4. This was approximately a 26% reduction in vibration level compared to when the treadmill #4 was being used. This change can be attributed to moving the treadmill to a location of higher floor stiffness adjacent to a vertical steel support column within the wall, and also moving the treadmill away from the center of the “drum head” membrane of the exercise center floor.
